CLMP and Water Quality Report

John Jackson
Membership Meeting, August 23, 2025

2024 Twin Lakes CLMP Results

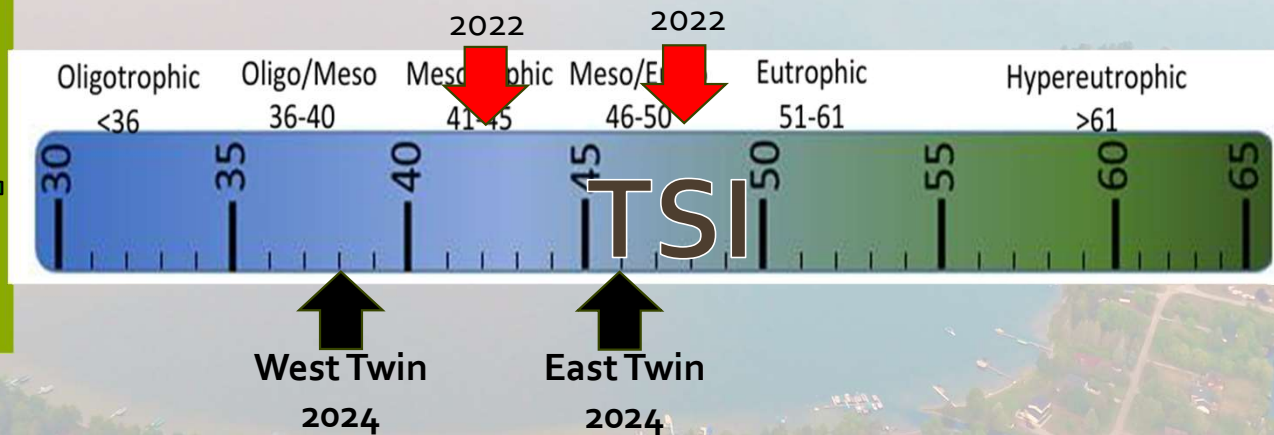
- ✓ West Twin: Average TSI score of 38 this lake is rated between the oligotrophic and mesotrophic lake classification. The lake leans slightly more **oligotrophic than mesotrophic. (4 point improvement)**
- ✓ East Twin: Average TSI score of 46 this lake is rated as **mesotrophic. (2 point improvement)**

1. Water Clarity results were like longstanding CLMP results; West Twin Lake approximately 2 feet greater Secchi depth than East Twin
2. Composite trophic state and nutrient calculations also duplicated CLMP results, West Twin **oligotrophic**, East Twin Lake is **mesotrophic**.
3. As expected, dissolved oxygen declined throughout the season, with fall levels dipping below USGS summer guidelines
4. The algal risk assessment showed non-detectable concentrations of toxic-producing cyanobacteria. As a result, **no immediate risk** of Harmful Algal Blooms (HABs)
5. Continue environmental management of invasive species, reduce waterfowl droppings and improve erosion reduction.
